National Register of Historic Places – Sample Nomination Form Bridgeton Historic District, Parke County, Indiana

National Register of Historic Places Registration Form

Section number _	_7	Page1	l	Bridgeton Historic District, Parke County, IN

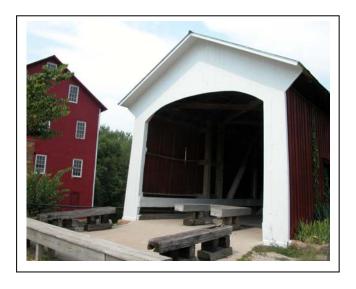
Bridgeton Historic District includes a variety of building types. The mill at left provided the industrial base to the town's economy in the 19th and early 20th centuries.
